# 7<sup>th</sup> International Conference on Debris-Flow Hazards Mitigation

# Debris flows in the North Pacolet River valley, Polk County, North Carolina, USA - case studies and emergency response

Jennifer B. Bauer<sup>a\*</sup>, Richard M. Wooten<sup>b</sup>, Bart, L. Cattanach<sup>b</sup>, Stephen J. Fuemmeler<sup>a</sup>

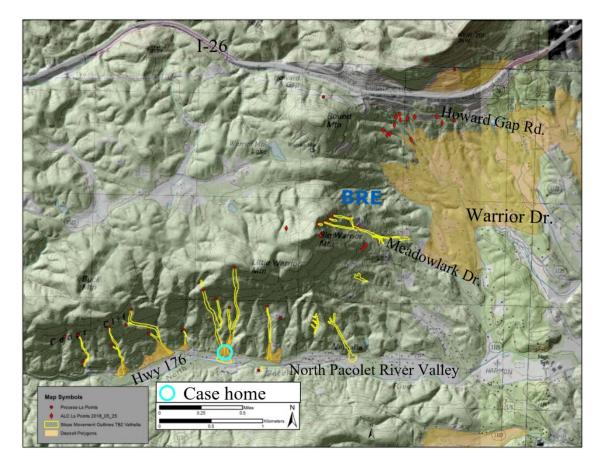
Fig. 2. 2004 hillshade draped with Saluda 1:24,000 quadrangle topographic map. Debris flow outlines are yellow polygons, red points are slope movement initiation zone locations; tan polygons are slope movement deposits. Data from NCGS and ALC geodatabases, 11/01/2018. Home location of Mr. and Mrs. Case is highlighted.

Many of the debris flows deposited material in areas where prior slope movement deposit material was observed or mapped using a lidar-based digital elevation model. In some locations, pre-existing deposits were incised during the May 2018 event (Fig 2). Many of the homes that were damaged were constructed on these past debris flow deposits.

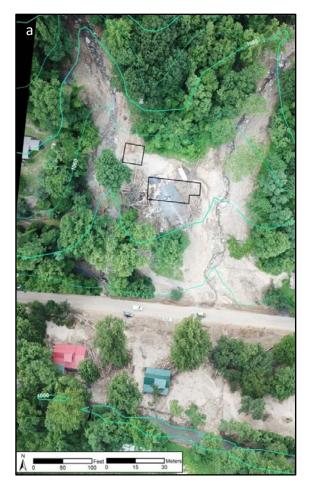
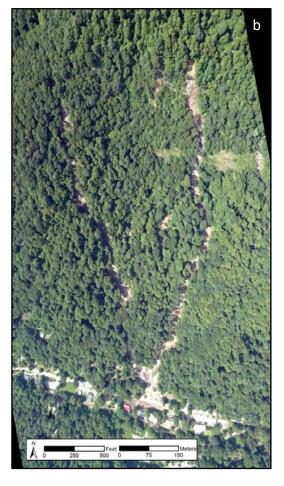
On the evening of May 18, 2018, heavy rains inundated the Pacolet Valley and surrounding area, triggering debris flows, other types of slope movements, and flooding in the area. The home of Mr. and Mrs. Case was initially hit by a debris flow from the eastern drainage above their home (Fig 2, Fig 3). The Cases tried to get out of their home at that time, but Mrs. Case was not able to due to health complications. Mr. Case assisted Mrs. Case into a detached garage next to the home. He then left, wading through the mud trying to get help, when a second debris flow from the western drainage behind the home hit the garage (Fig 3). Mr. Case tried to get back to the house to get to his wife, but was unable to do so. Early the morning of May 19, Polk County Emergency Management (EM) requested assistance from North Carolina Geological Survey (NCGS) to determine if slopes above the home were stable enough for crews to get to Mrs. Case. Sadly, she was not alive when crews were able to access the garage.

Fig. 3. (a) Georegistered 2018 UAV Image from the NC Geodetic Survey. Original location of Case home and detached garage outlined in black. (b) Georegistered 2018 Aerial Image from the NC Forest Service. Two debris flows that merged at the base of Little Warrior Mountain at the Case home location along Highway 176.

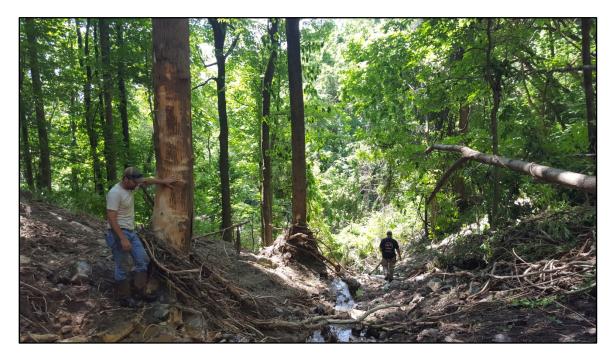
Fig. 4. Downstream view of debris flow in the Meadowlark Drive area. Tree nick marks can be observed twice as high as the height of the worker by the tree, approximately 3.6 meters high (12 feet).
