Debris Flows, Rock Slides, Rock Falls and Big Slow Movers: Who Could Ask for Anything More?

Field Course #3

Association of Environmental & Engineering Geologists
62nd Annual Meeting

September 17-22, 2019
Asheville, North Carolina

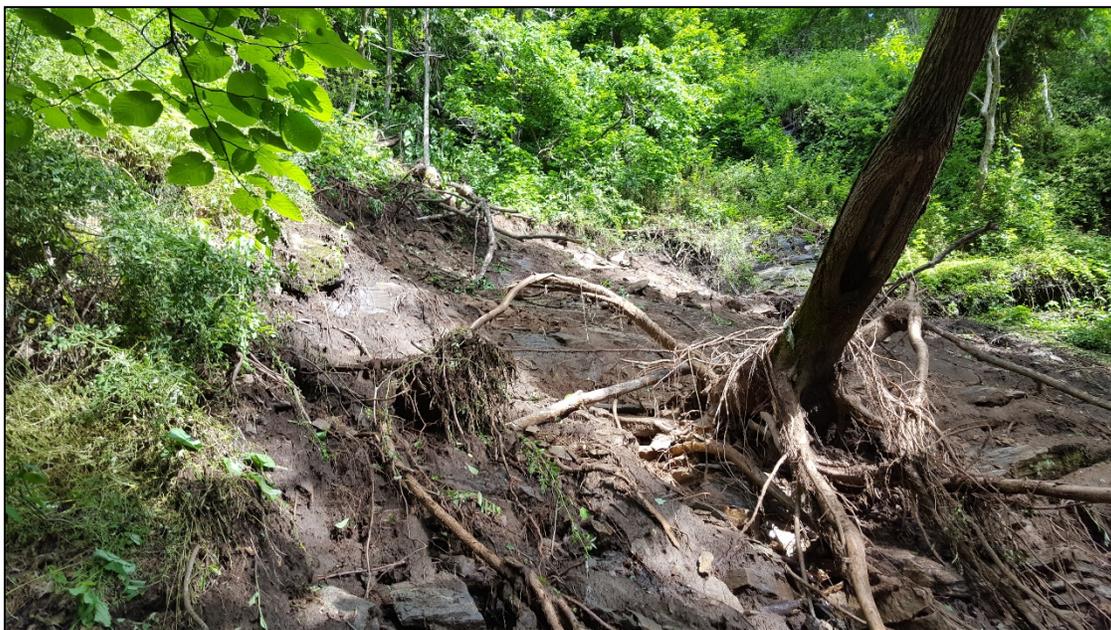
Figure 1.4. Debris flow 3 initiation zone. Failure plane is at colluvium/bedrock contact. Bedrock observed in center of photo. Photo by Appalachian Landslide Consultants, PLLC on May 23, 2018.

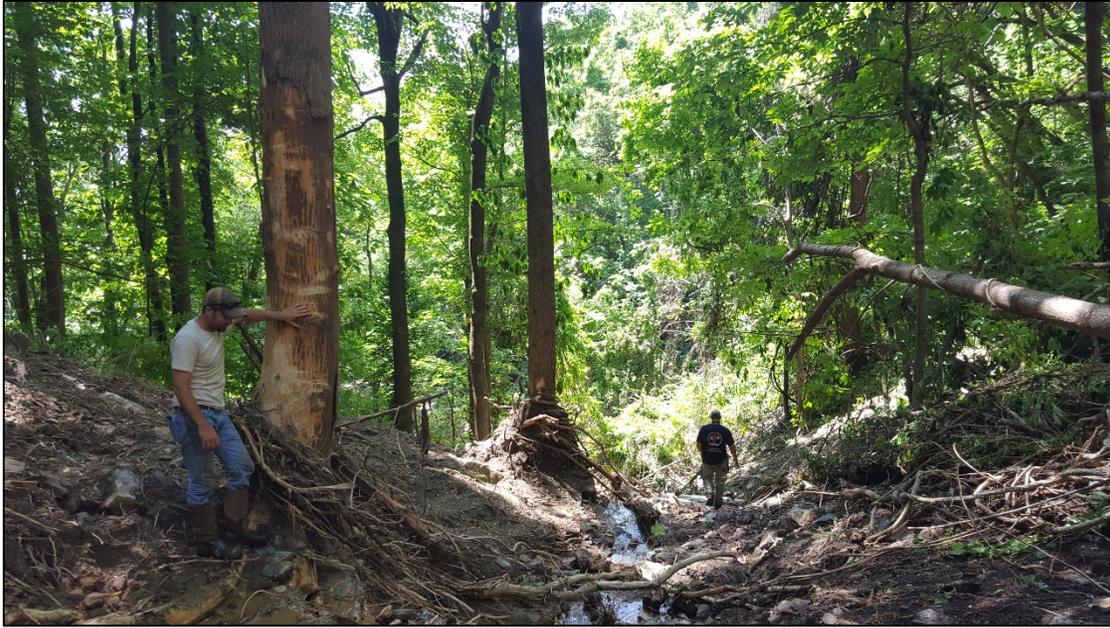
Figure 1.5. Looking down slope of track for debris flows 1 and 3 upslope of driveway for 1080 Meadowlark Dr. Debris and/or trees were at least 12 ft (4 m) deep, based on tree nick marks. Photo by Appalachian Landslide Consultants, PLLC on May 23, 2018.

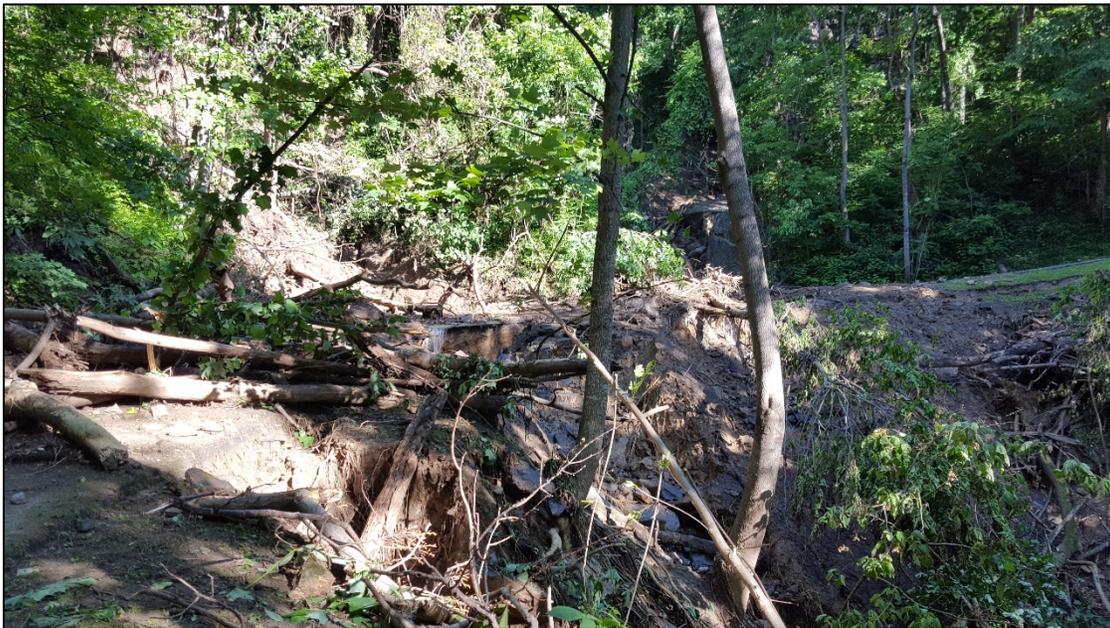
Figure 1.6. Tracks for debris flow 1 and 3 coalesced just upslope of driveway for 1080 Meadowlark Dr. Majority of driveway was taken out. Photo by Appalachian Landslide Consultants, PLLC on May 23, 2018.

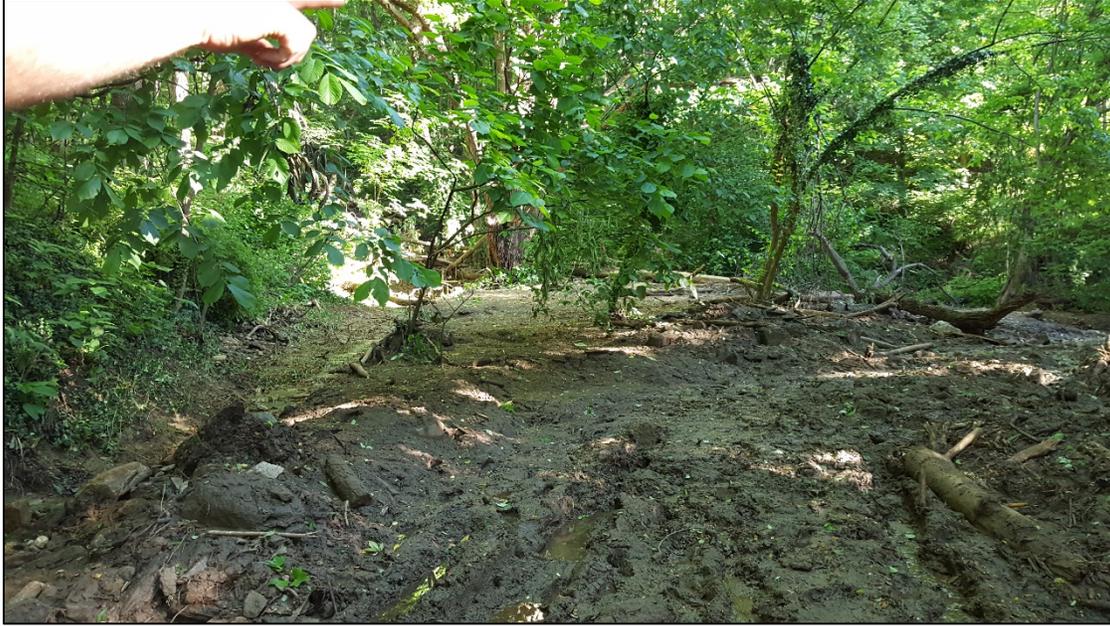
Figure 1.7. Debris covering Valley View Ln. upslope of 502 Meadowlark Dr. Road is under debris on right side of photo. Culvert is completely blocked. Photo by Appalachian Landslide Consultants, PLLC on May 23, 2018.

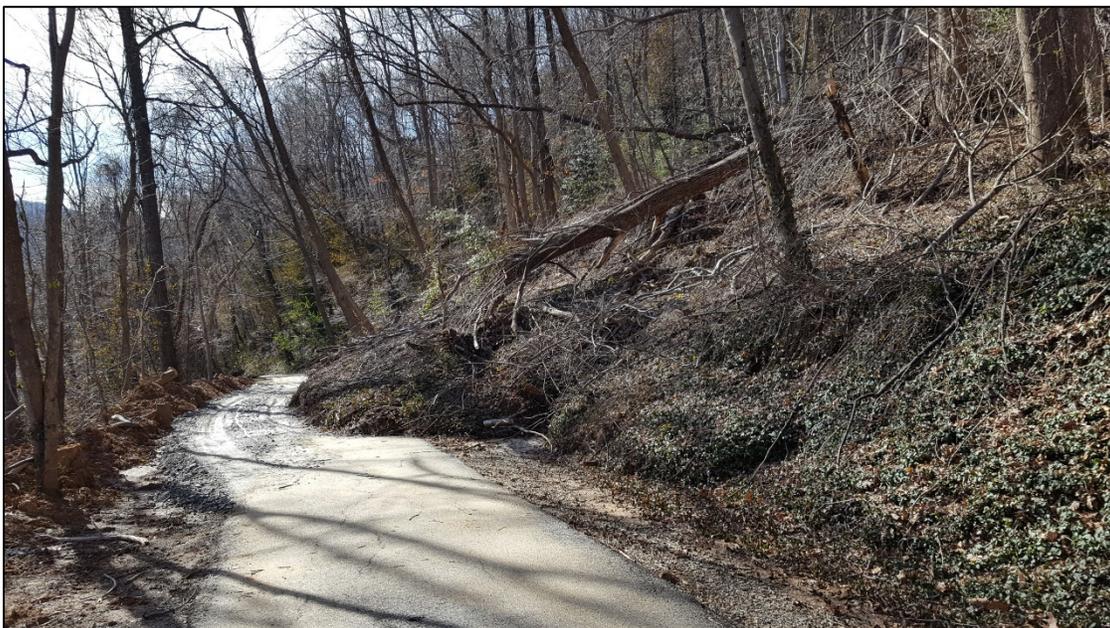
Since May, 2018, a deep-seated debris slide has been covering the upper portion of Meadowlark Drive, blocking the driveway to the home at the end of the road (Fig 1.8). This slide appears to be a reactivation of a larger dormant-old landslide, based on a review of the lidar and field verification of older scarps upslope of the active scarp (Fig. 1.3).

Figure 1.8. Toe of debris slide on driveway for 1080 Meadowlark Drive. Photo by Appalachian Landslide Consultants, PLLC on January 21, 2019.

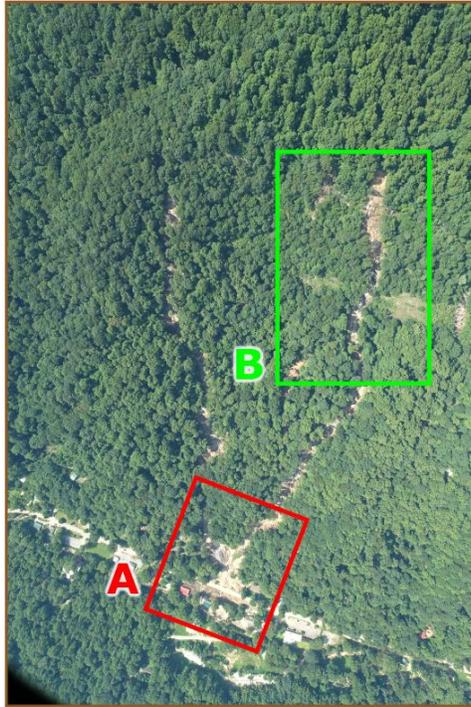
Figure 2.2. Two debris flows merged at the base of Little Warrior Mtn at the Case home. 2018 Aerial Image from the NC Forest Service.

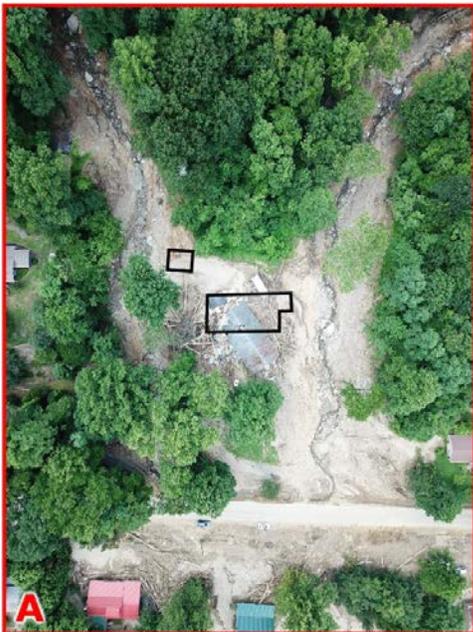
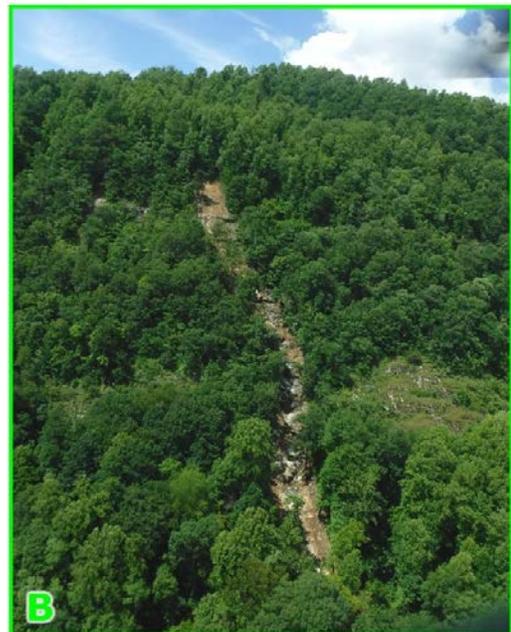
Figure 2.3. Locations of these photos are shown on previous figure. A) Original location of Case home and detached garage outlined in black. Georegistered 2018 UAV Image from the NC Geodetic Survey. B) Debris flow initiation zone (IZ) upslope of cliffs on the edge of the Blue Ridge Escarpment.

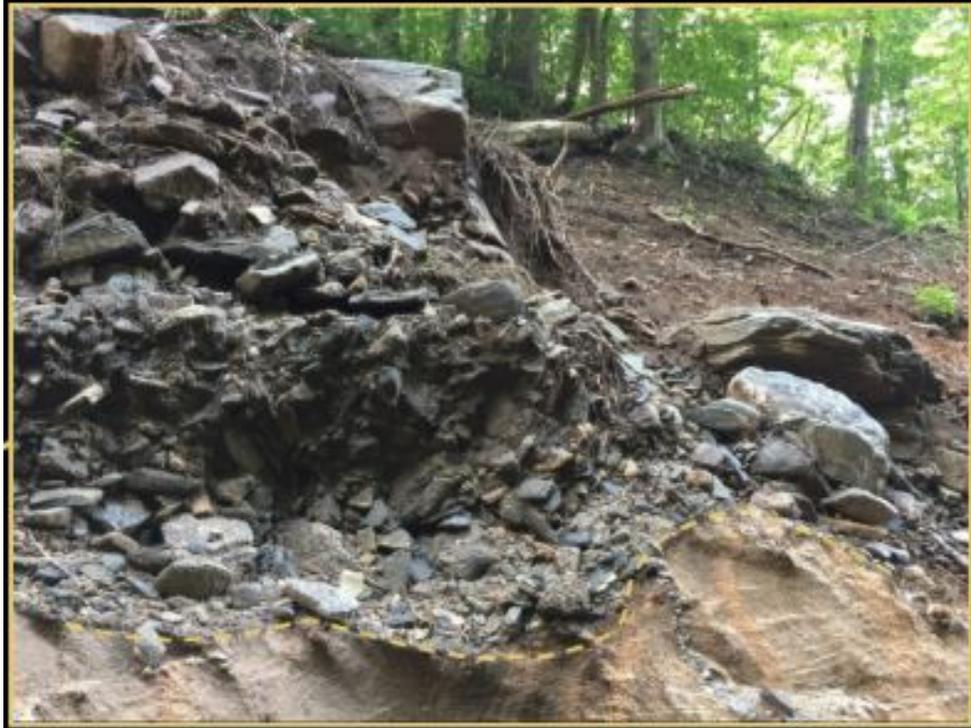
Figure 4. Landslide debris deposit exposed by scour in western drainage upslope of Case home. Multiple vintages of deposit evident in the cross-section. Photo by NC Geological Survey May, 2018.

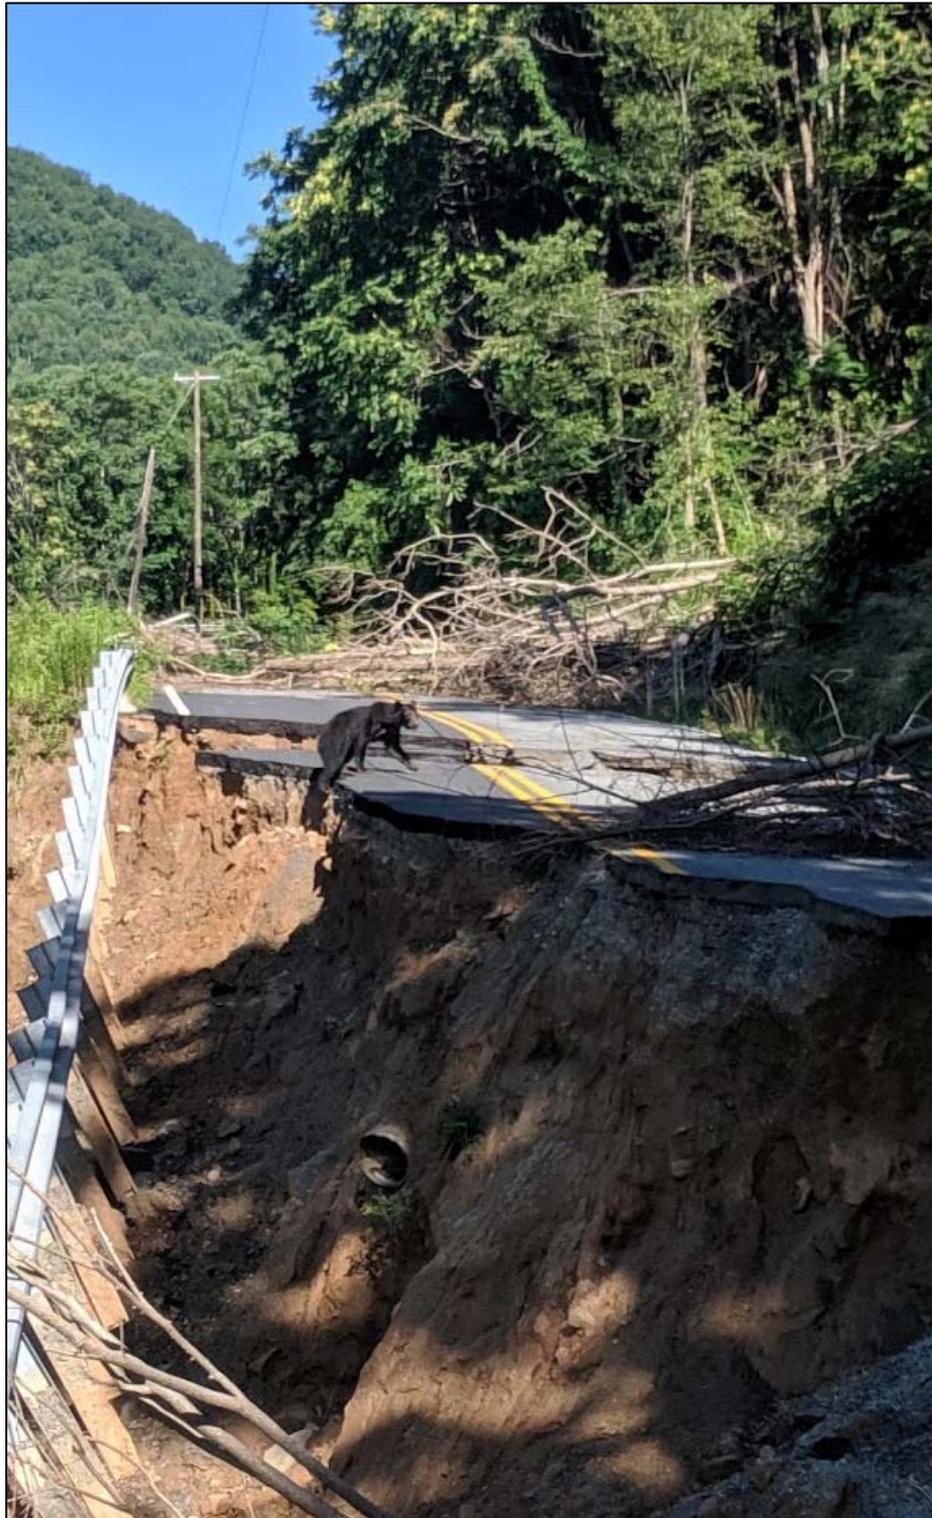
Figure 3.3. View of the eastern segment of the main scarp of the debris slide cutting across Howard Gap Road. Slide movement is toward the left (south). View looking west. Damage from the slide resulted in closure of the road to vehicles, making it *bearly* passable to local residents. 2018/06/14 NCGS C. Scheip photo.

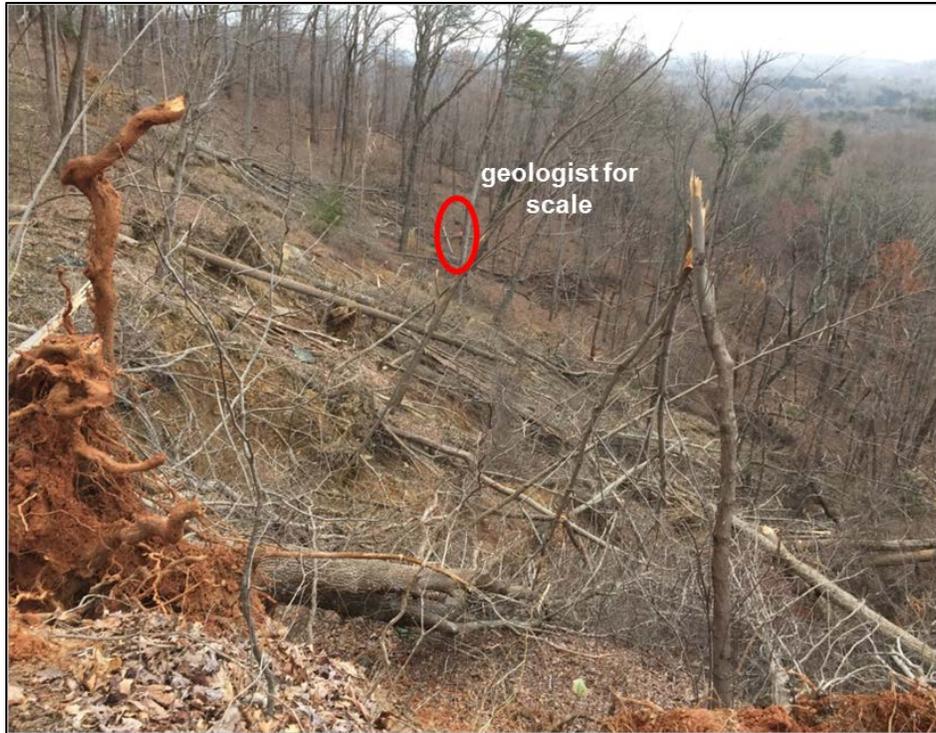
Figure 3.4. View of the south-facing slope of the slide with trees downed from slide movement. Slide movement is toward the right (south). View looking east. 2018/03/14 NCGS photo.

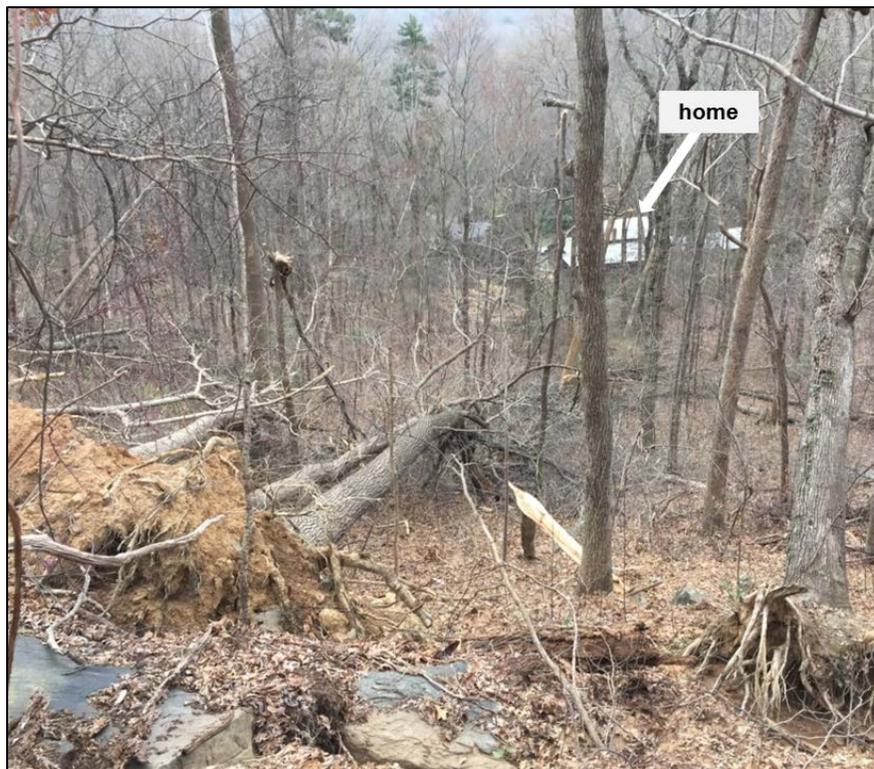
Figure 3.5. View of the south-facing slope of the slide with trees downed from slide movement. Boulders in foreground left are clasts within the debris deposit. Slide movement is away from viewer toward the home (south). 2018/03/14 NCGS photo.

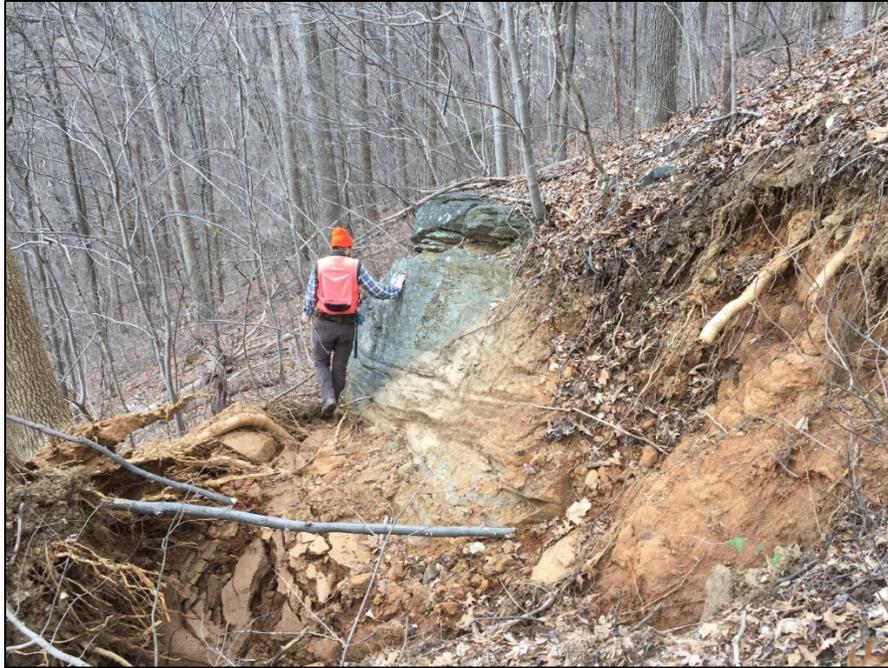
Figure 3.6. Vertical displacement on the right lateral scarp of the debris slide. Boulders exposed in the scarp are clasts within the pre-existing debris deposits on the slope. NCGS geologist Bart Cattanaach stands on the slide mass. View looking south-southwest, slide movement is toward the south. 2019/03/14 NCGS photo.

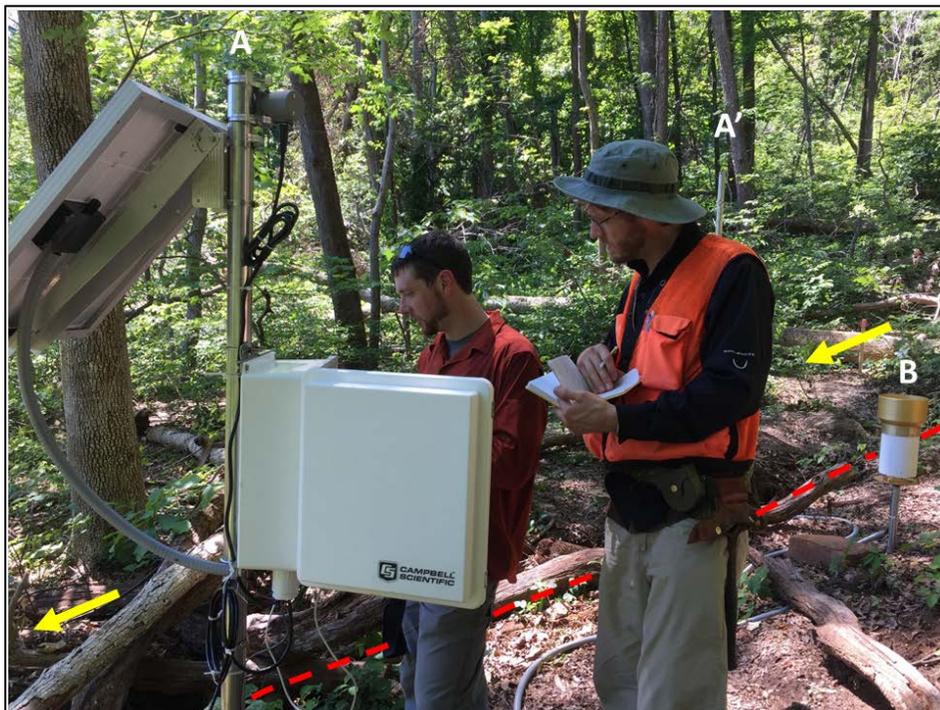
Figure 3.7. NCGS geologists Corey Scheip (L) and Jesse Hill (R) downloading data at monitoring site HG-1 located along the left lateral scarp (red dashed lines) of the Howard Gap debris slide (see Fig. 3.2 for location). Yellow arrows indicate slide movement direction toward the south. A and A' = anchor posts for the cable extension transducer; B = tipping bucket rain gauge. 2019/05/22 NCGS photo.

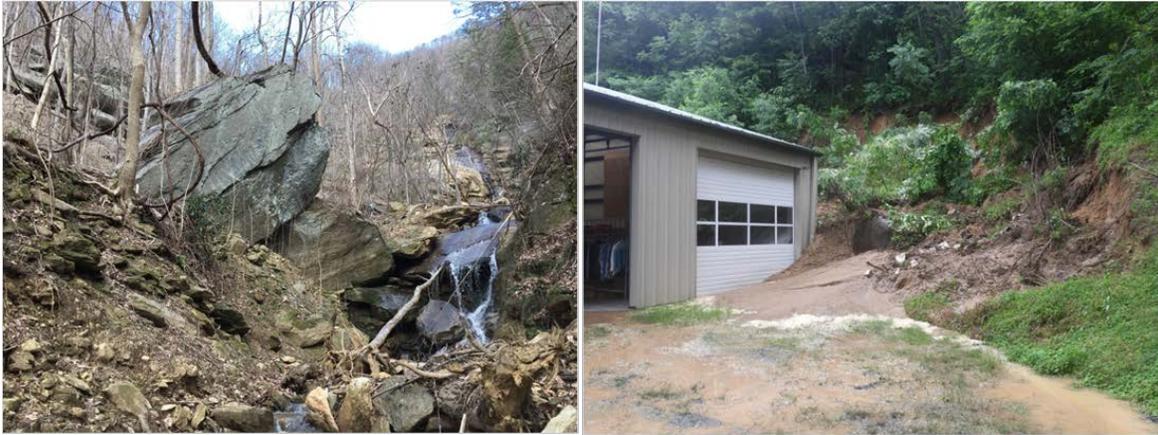
Figure 4.3. Left: View looking upslope (north) along the path of the debris flow (embankment failure) that damaged a Village of Chimney Rock park. 2019 NCGS photo. **Right:** Damage to the Chimney Rock Volunteer Fire Department (CRVFD) by a May 30, 2018 debris slide (cut slope failure) triggered by subtropical depression Alberto. View looking northwest. 2018/05/30 CRVFD photo.

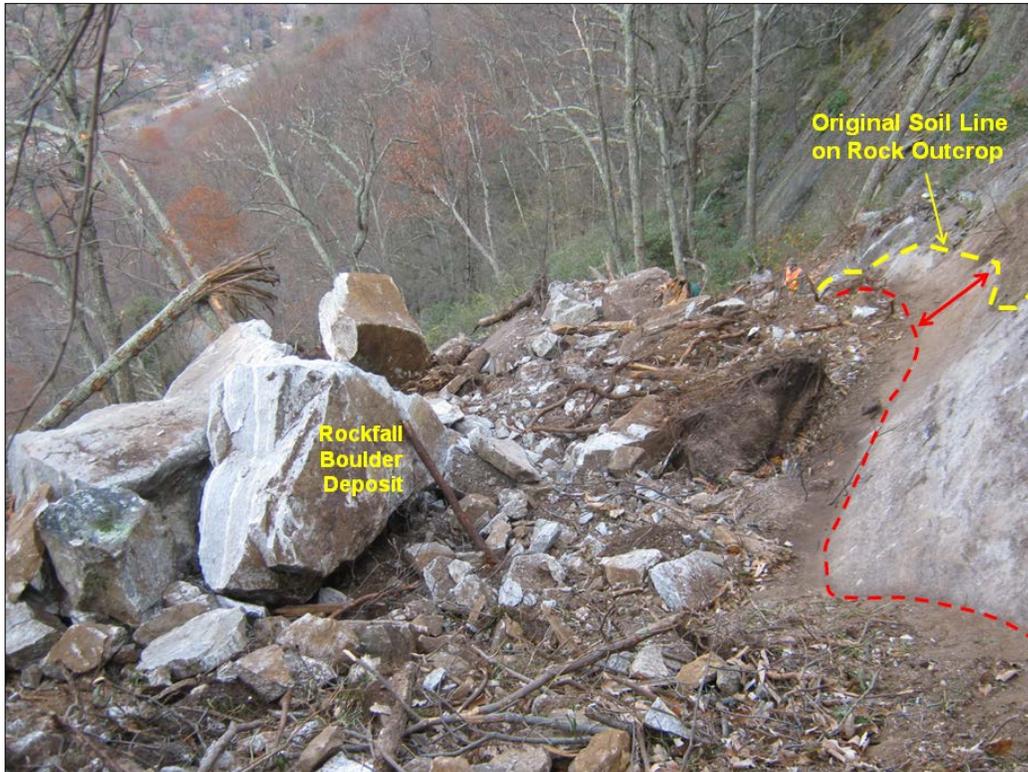
Figure 4.7. Displacement along the scarp of the debris slide developed here along the contact between bedrock and pre-existing rocky colluvium overlain by boulders from the November 14, 2012 rockfall event. The displacement is shown by the distance between the yellow and red dashed lines. 2012/11/19 NCGS photo.

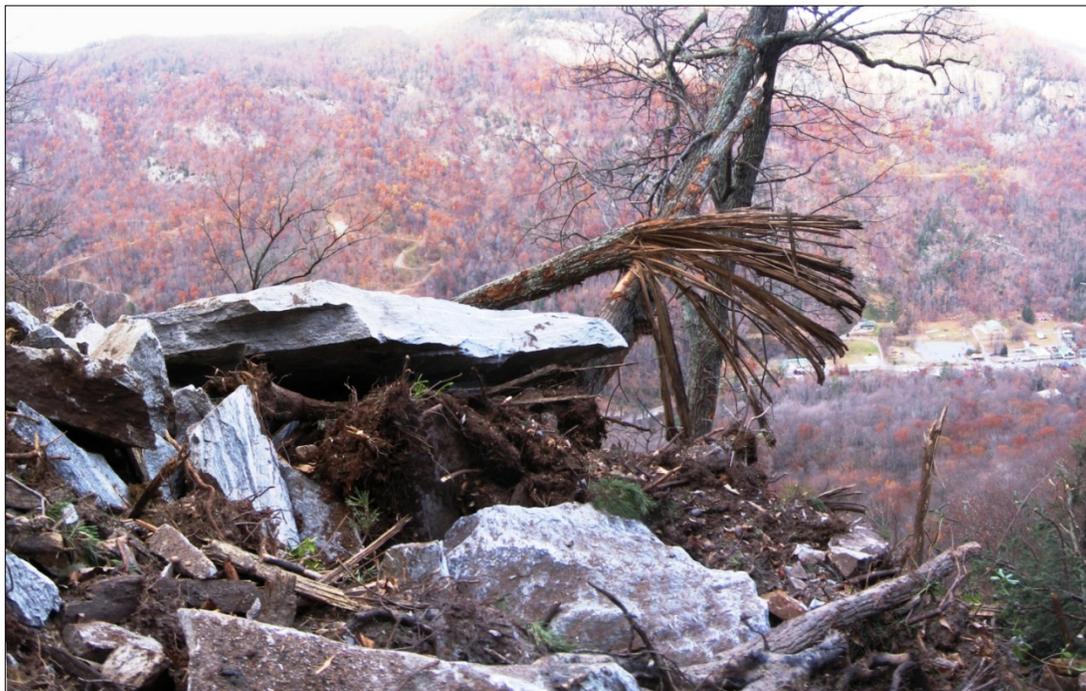
Figure 4.8. Unstable boulder deposit and trees damaged by the November 14, 2012 rockfall event. 2012/11/19 NCGS photo.

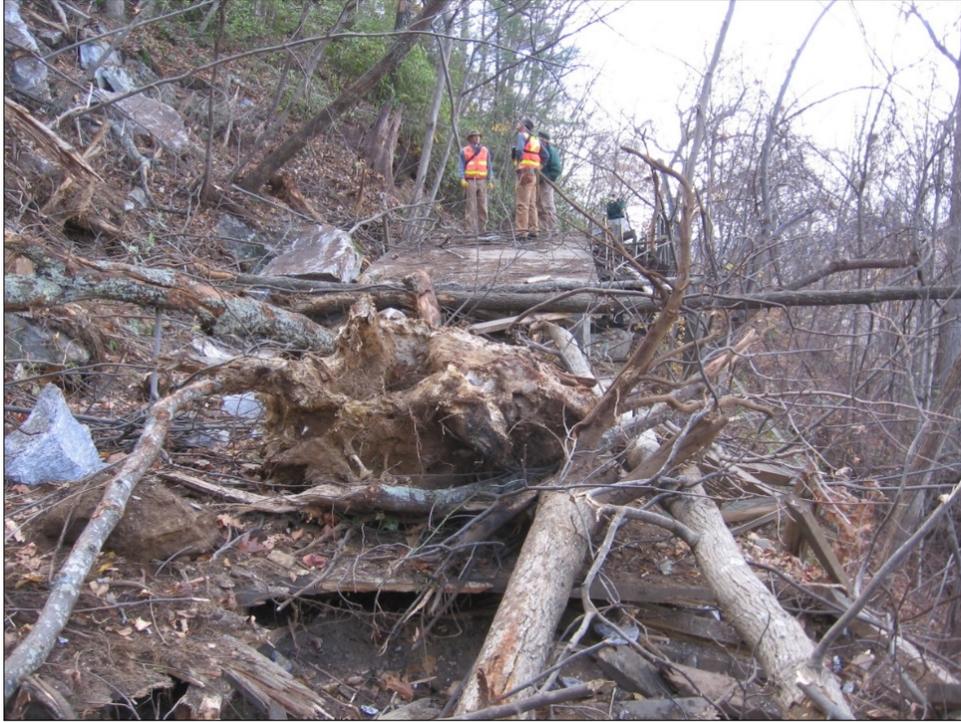
Figure 4.9. Severe damage to the footbridge on Hickory Nut Falls trail caused by rockfall and trees downed by the rockfall. 2012/11/19 NCGS photo.

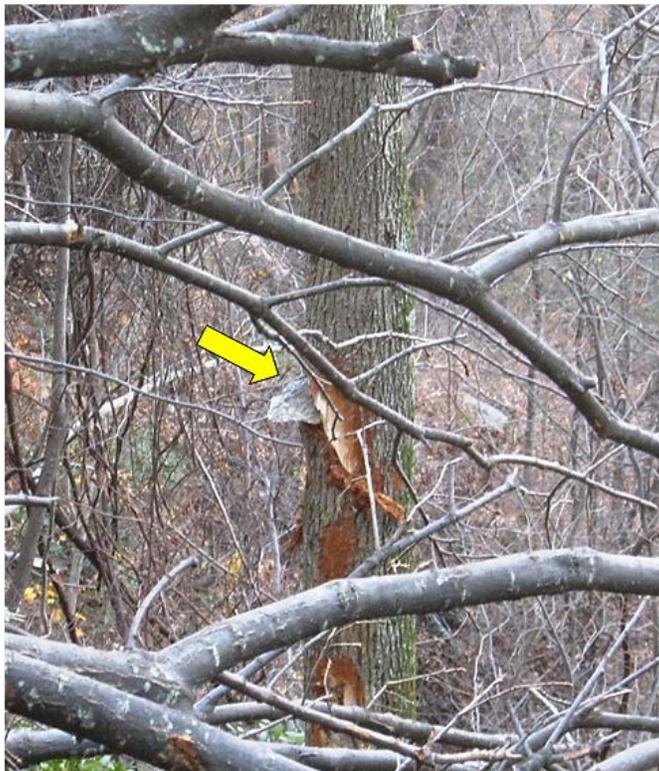
Figure 4.10. Arrow points to rock projectile from the November 14, 2012 rockfall imbedded into a tree below the Hickory Nut Falls trail. The rock fragment is about 8-10 feet above the base of the tree. 2012/11/19 NCGS photo.

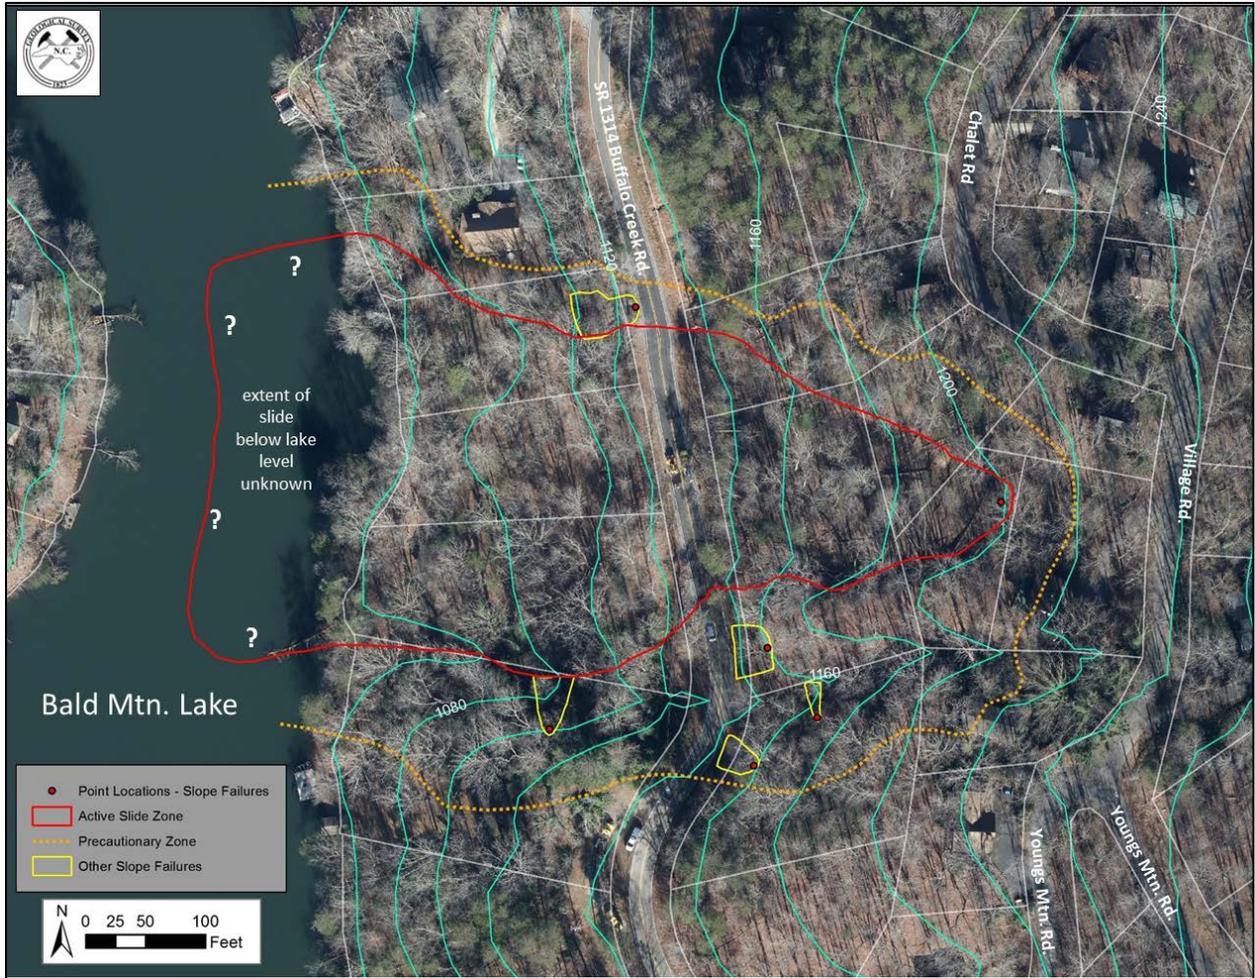
The Buffalo Creek debris slide has a documented history of movement over a 45-year period. A 1988 NCDOT memorandum (NCDOT, 1988) documented that NCDOT investigated the slide in 1974 and 1980. In that memorandum the author concluded that, “The slide has the potential to continue movement indefinitely, varying in speed with the seasons. Movement will be faster in the rainy season, but is unlikely to stop completely.” Reconnaissance by NCGS geologists in 2006 noted distress to Buffalo Creek Road (SR 1314) in this area indicative of slide movement at some time. Recent movement became apparent in May of 2018 at which time the NCDOT took measures to the repair SR 1314. The NCDOT was notified of further movement on January 2, 2019 and subsequently closed the road to traffic.

Figure 5.2. Provisional map of the Buffalo Creek debris slide area showing the active slide zone and precautionary zone and other slope movement features as of 2019/04/02. Topographic contours (20-foot contour interval) derived from a 20-foot pixel resolution LiDAR (Light Detecting And Ranging) digital elevation model. LiDAR data acquisition pre-dates recent slide movement. Approximate land parcel boundaries (white) courtesy of the Rutherford County GIS Department. Map base is 2019 unmanned aerial systems (UAS) ortho-mosaic provided by NCDOT. Data Sources: NCGS and NCDOT. **Notes:** 1. All locations and boundaries are approximate. 2. Areas of ground cracks within the active slide and precautionary zones are not shown. 3. Map unit boundaries are subject to change as slide conditions and extents may change. 4. This map is not a substitute for a map prepared by a licensed land surveyor.

Issuance of building permits or property sales in the active slide or precautionary zones should be accompanied by disclosure of the information regarding the debris slide and potential hazards, including the potential for enlargement of the active and precautionary slide zones.

Repairs to structures to maintain their structural integrity in response to ground movements within the active and precautionary slide zones should be done under guidance of qualified structural and/or geotechnical engineers.

Long term monitoring of the active and precautionary slide zones is recommended, but is beyond the resources and authority of the North Carolina Geological Survey.

Any new construction in the active slide zone is not recommended and should be done with extreme caution, and under the guidance of qualified geologists and/or engineers.

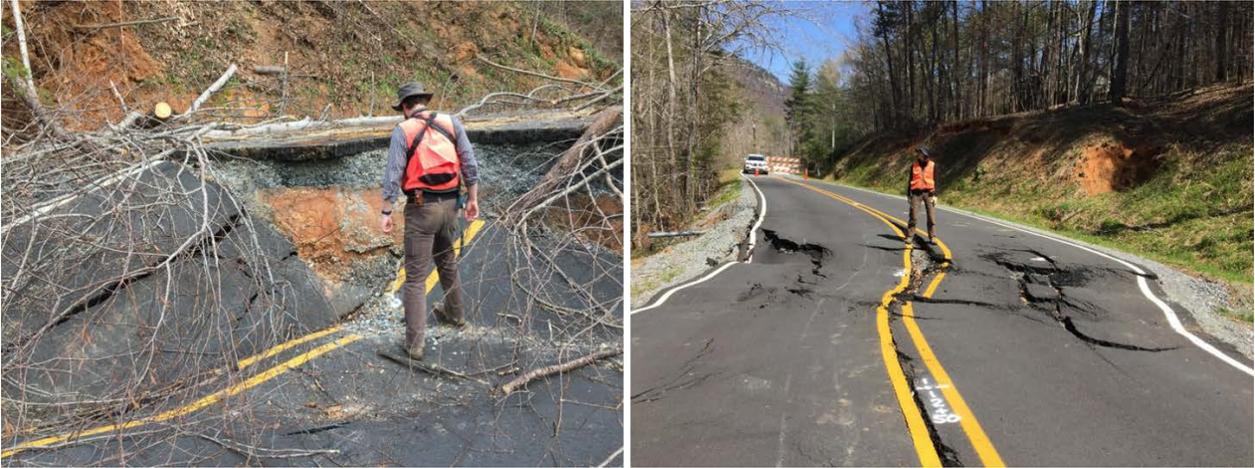
Figure 5.3. Left: Displacement of Buffalo Creek Road (SR 1314) on the left lateral scarp on the south side of the debris slide. View looking south. 2019/03/07 NCGS photo. **Right:** Displacement of Buffalo Creek Road (SR 1314) on the right lateral scarp on the north side of the debris slide. View looking north. 2019/04/02 NCGS photo.

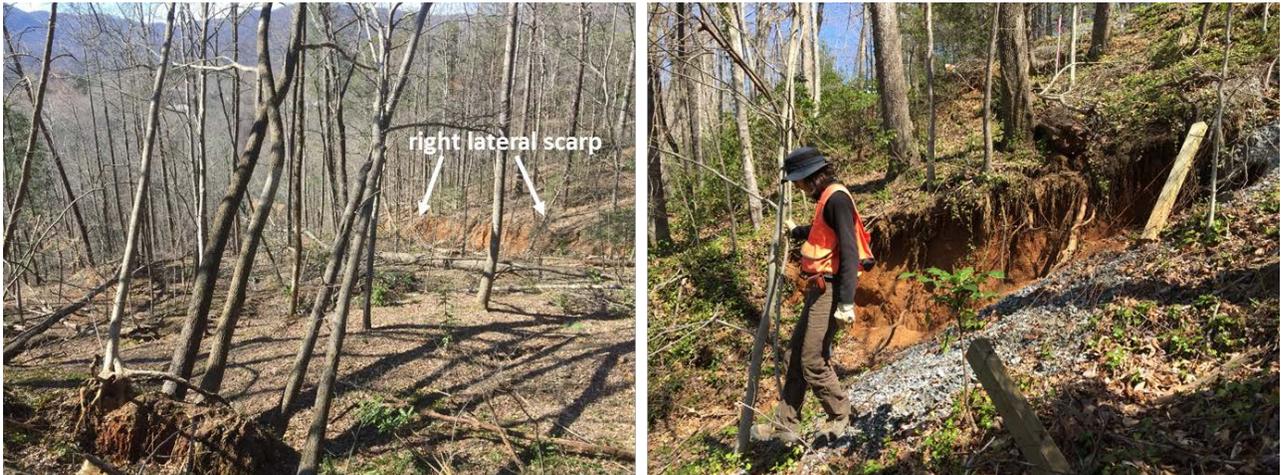
Figure 5.4. Left: Leaning trees within the slide mass upslope of Buffalo Creek Rd. (SR 1314). View looking northwest toward the right lateral scarp. 2019/03/07 NCGS photo. **Right:** Displacement on the right lateral scarp on the north side of the debris slide downslope from Buffalo Creek Rd. (SR 1314). View looking north. 2019/04/02 NCGS photo.
